## SOLAR FEASIBILITY ANALYSIS

November 1st, 2013

The following analysis was conducted for the **Borough of Dormont** to determine whether the use of solar energy is feasible on the property known as the 'Dormont Pool and Recreation Center'. This feasibility analysis included inspections of the existing roof conditions, electrical systems of the building, shade analysis readings, a summary of the utilities bills for this property, a financial analysis and a proposed layout.

Borough of Dormont  
Dormont Pool House  
Dormont Avenue, Dormont, PA

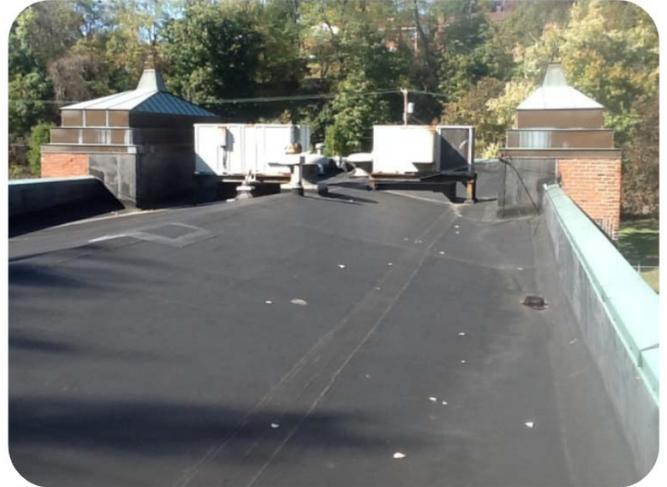
### Roof Condition Report

**Summary:** The inspection report revealed that the roof is beyond its serviceable life and will be in need of replacement within 1-2 years. Borough maintenance on the roof has been obviously diligent and has extended the life of the roof well past its warranty. Due to the nature of solar having a 25-year production warranty, the roof conditions would need to be 'good' or 'excellent' to recommend placing solar equipment on the existing surface. Replacement of the roof would be necessary prior to installing any solar equipment.

Recommendations for replacing the roof with a white reflective TPO surface (Cool-Roof) and adding insulation up to current code requirements are included herein as additional methods for saving energy. (see Roof Life Cycle Savings Report in appendix)

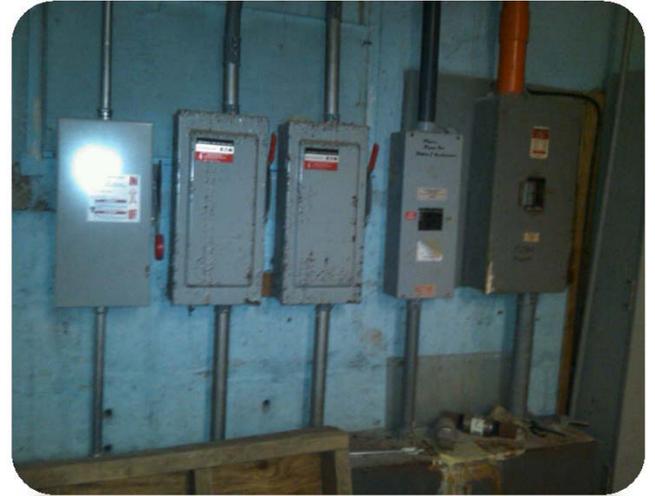
### Electrical System Report

**Summary:** Existing conditions of the electrical system denote an outdated but operational system. Two separate services to the building currently exist; a three-phase service and a single-phase service. Both utilize 400 amp service-entrance disconnects that feed to additional equipment disconnects and one lighting panelboard through electrical wireways. Though the current conditions of the electrical system are functional, updating of the electrical equipment is suggested.

As is, the existing electrical system is suitable for a rooftop solar array only. In order to get the 154kW to power the entire facility, updating and upsizing of the service would be required.

***A 154kW Solar PV System would yield a maximum output current of 417 amps at 208V, requiring a 600 amp line-side service disconnect.***

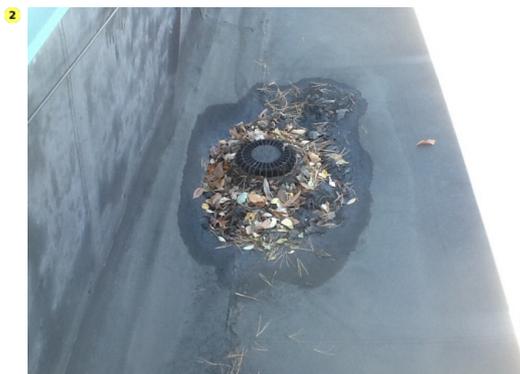
**General - Loose Debris (Remedial)**

Quantity: 50 SF

**Deficiency:**

Loose debris has a high probability of blowing around on the roof and causing damage to the waterproofing membrane.

Remove loose debris from roof area.

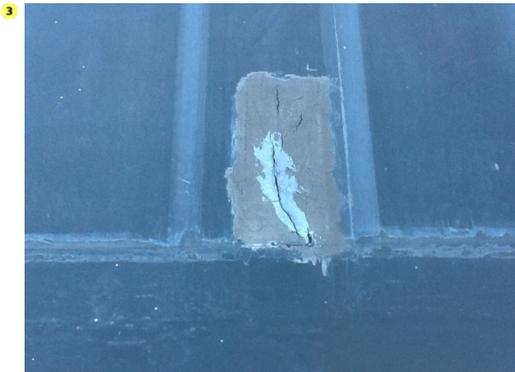
**General - Previous Repair Failure (Emergency)**

Quantity: 1 EA

Existing repair failing due to age or improper repair.

We will remove the existing repair, clean and prime area, and install new patch to ensure water tightness.

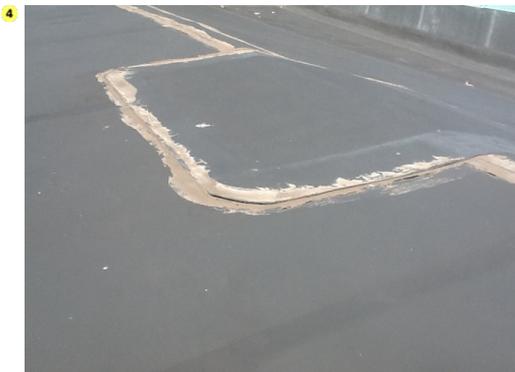
**General - Open Seams (Emergency)**

Quantity: 100 LF

Open seams in the waterproofing membrane are typically caused by failing seam adhesives coupled with membrane shrinkage and stress on the seams.

The area surrounding the open seam must be cleaned. A new piece of waterproofing membrane would be installed and sealed per industry standards.

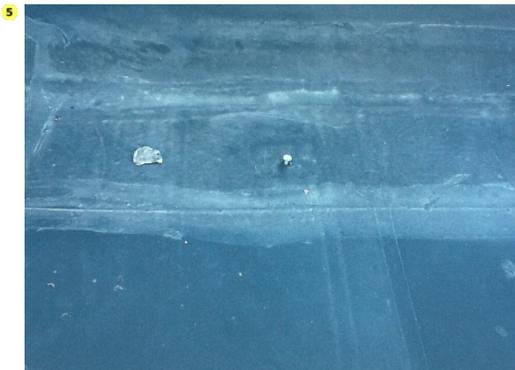
**General - Physical Damage (Emergency)**

Quantity: 1 EA

Fasteners are no longer securing the roofing system in place

Replace the loose fasteners and overlay the open holes

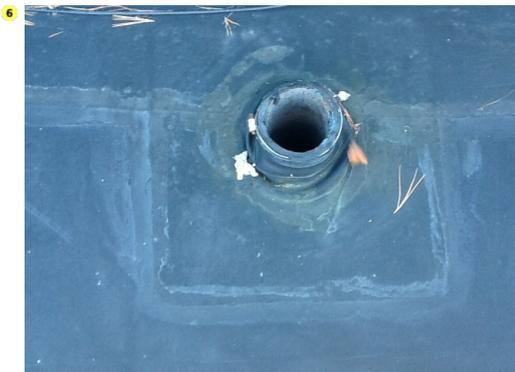
**General - Bridging (Emergency)**

Quantity: 1000 SF

Tenting of the membrane is caused by the overall shrinking that takes place over time. The shrinking of the membrane causes it to pull away from perimeter walls and creates stress of the flashing areas of the roof. This and the membrane has become no longer adhered to the insulation.

The existing membrane would need to be cut and allowed to relax and a new piece of flashing membrane spliced in to ensure a water tight seal. Due to the amount of loose membrane, large sections of this roof will also need to be opened up and readhered.

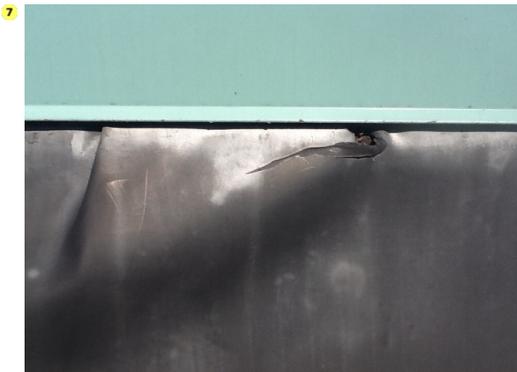
**General - Physical Damage (Emergency)**

Quantity: 1 EA

Damage to any roof system or drainage system that is caused by storms, negligence, or remodeling, etc. that is not consistent with normal weather or age-related conditions.

Repair or replace any damaged membrane or materials needed to restore the roof system or drainage system back to original condition.

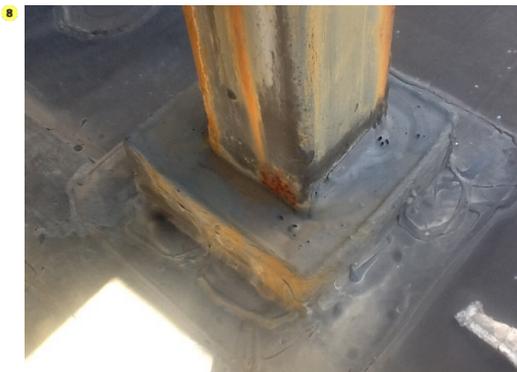
**General - Failing Penetration (Commercial) (Remedial)**

Quantity: 8 EA

Due to overall age, weathering, and UV, the penetration has failed.

The penetration should be repaired/flushed per industry standards to ensure a water tight seal.

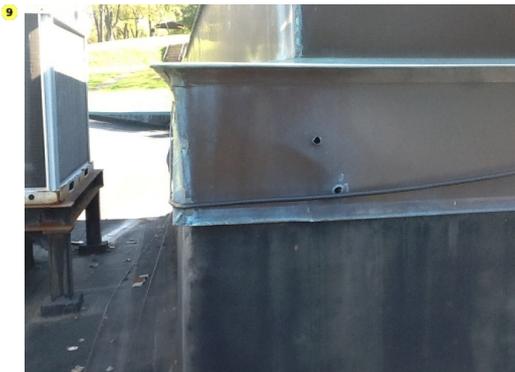
**General - Physical Damage (Emergency)**

Quantity: 2 EA

Damage to any roof system or drainage system that is caused by storms, negligence, or remodeling, etc. that is not consistent with normal weather or age-related conditions. The securement of the wire bracket has pulled out of the metal.
