Report
On
Council Borough Asset Assessment
Fact-Finding Tour I
May 10, 2014

Summary Table of Recommendations Developed as the Result of Council’s May 10, 2014 Asset Assessment Fact-Finding Tour

Report Council Borough Asset Assessment Fact-Finding Tour May 10, 2014

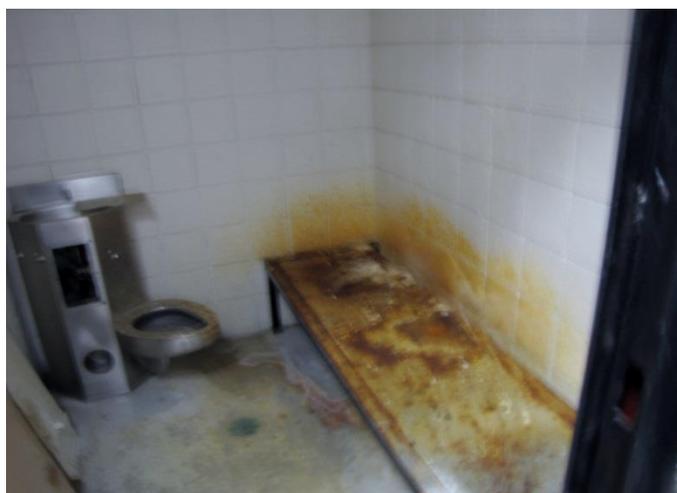
Based on discussions with long time Borough employees, water coming through the foundation has been a problem for many years. There have been sporadic and limited attempts to identify and mitigate this problem but they have largely been unsuccessful. Water issues are prevalent in the basement. The police department, Dormont Historical Society and the community room are all located in the basement. Water damage is clearly seen in these facilities but is also evident in some 1st floor areas as well.

Water leaking through the ceiling has made one of our jail cells unusable and presents a poor picture of Borough facilities. Leakage through the ceiling can't be controlled and until the larger infiltration issue is solved it will continue. While this is cosmetically clearly unacceptable, the continued leakage and presence of water will lead to deterioration of concrete and steel beams. Water damage is not limited to the holding cell area of the Police Department but can be seen throughout the Department and the entire basement. Below are a few pictures with each of their locations.

Council included \$100,000.00 in the Borough's FY2014 budget to address the water infiltration issue. This estimate however was based on best professional judgment of our Borough Manager and his staff. That may cover what is needed to be done to stop water infiltration but we have no estimate of what the cost will be to repair the damage already incurred to drywall, ceilings, the holding cell, etc. We will need to develop an estimate for the cost of those repairs.

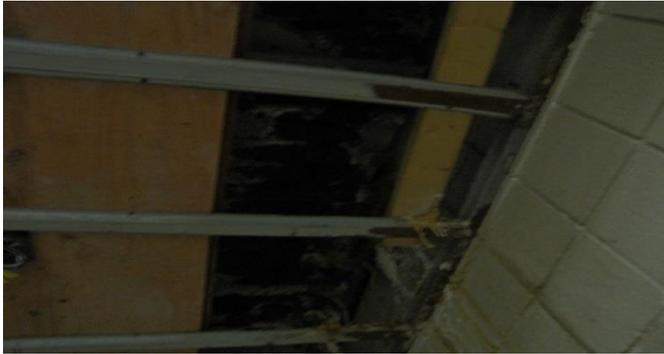
Water damage above the holding cell pictured above

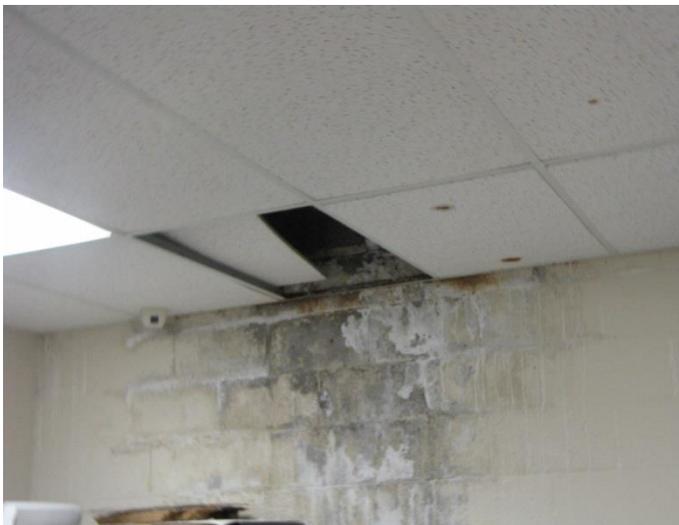
Ongoing water damage- rear wall of the Police Department

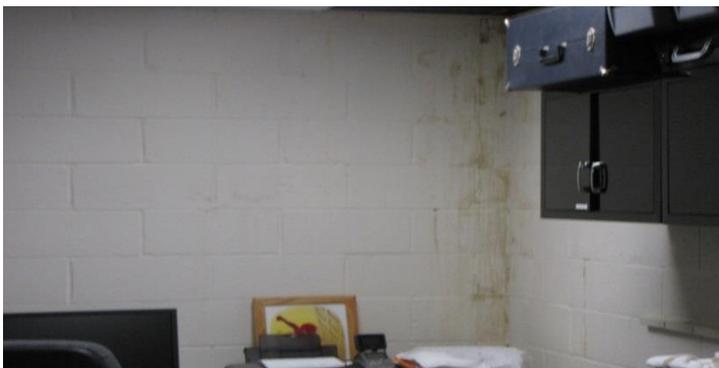
Ongoing water issue in the evidence room. Water makes the wall unsightly but also cause deterioration of concrete, dry wall and rebar. In addition, the presence of this moisture helps to maintain an unacceptable high humidity level which promotes the growth of mold and the deterioration of evidence.

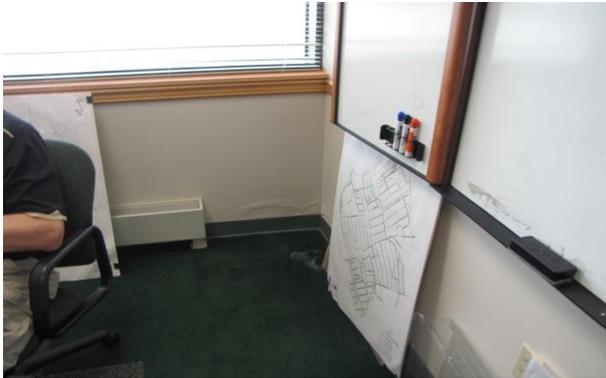
Efflorescence and water damage is evident in the corner of the 1st floor conference room.

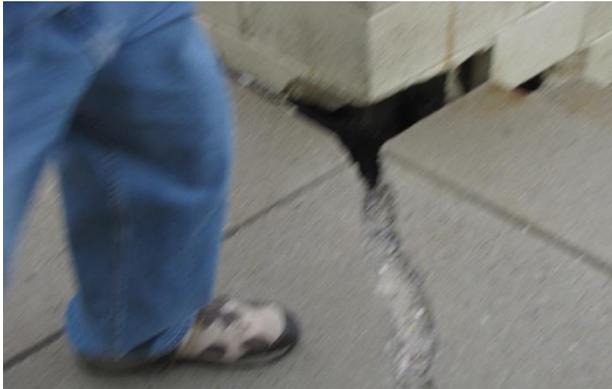
Picture 1- Top of Front Stairs and Landing

Pictures below are steps leading up to gym entrance on Espy side . First picture is at the top. Second picture is along the side of the stairs and 3rd picture is rear stairs and back wall each need work. Repair of the steps would not be successful- only solution is replacement. It is also likely that not only steps but other external concrete and brick restoration/replacement will be necessary. We currently do not have a cost estimate for all of that work

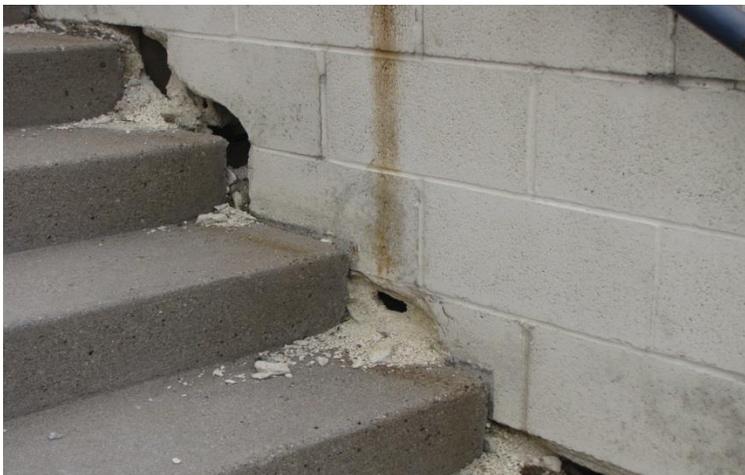
Picture 2- Side wall block deterioration along front stairs

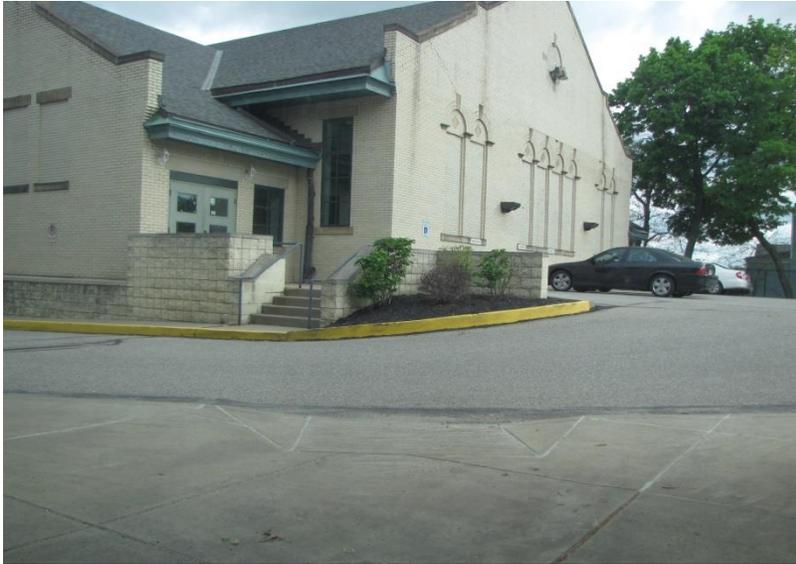
Picture 3- Rear brick wall and stairs need repair- money in budget for brick repair

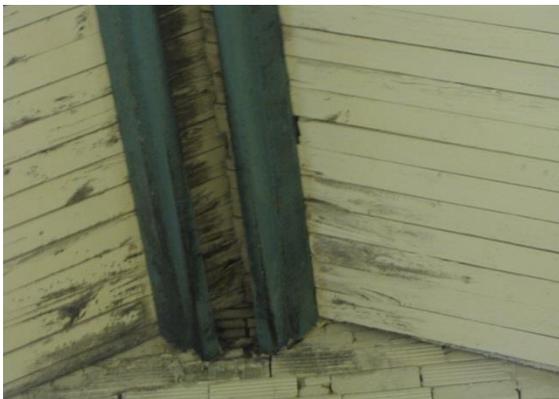
The gymnasium floor has been heavily utilized over the years and needs to be refinished and protected from certain activities. The walls are in terrible shape and the inside looks like a third world facility. The ceiling and internal brickwork are also problematic. It is at best an aesthetically unacceptable facility that we rent to the public and does not reflect well on the Borough. A few pictures will illustrate those points – We have no current estimates of the cost for this heavy cosmetic work.

Picture above- Gymnasium ceiling needs to be repaired and painted

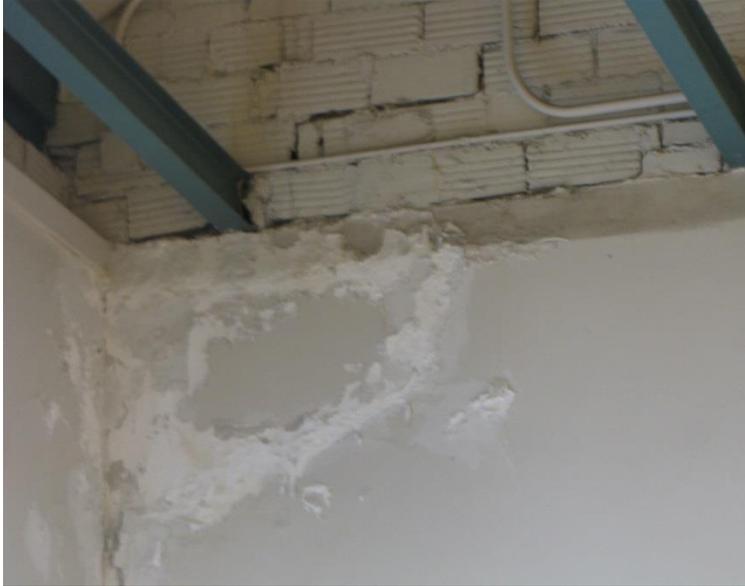
Picture above- Gymnasium Espy side upper wall showing damage to wall perhaps from water from clogged downspout. Also note seam separation between concrete blocks. It is Council's understanding that these separations do not indicate a structural issue with the wall of the roof but further inspection would seem to make sense. We have no current estimate of costs for that inspection or for any repair.

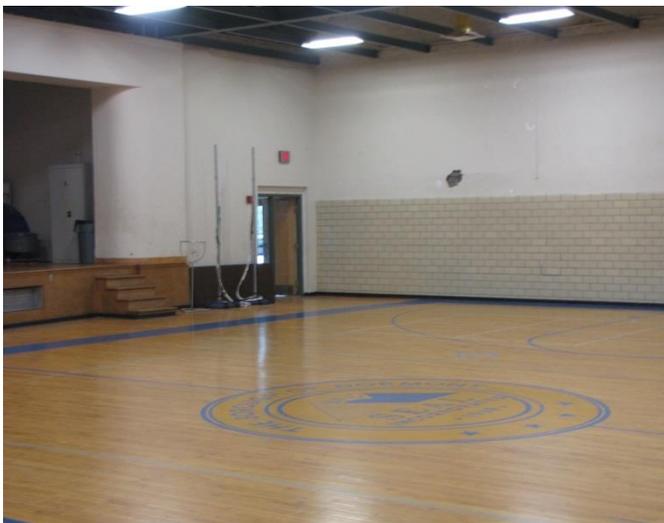
(Picture above) Note large hole in the wall at center of the picture. Such holes are prevalent throughout the facility and present an unacceptable appearance and are not compatible with acceptable standards.

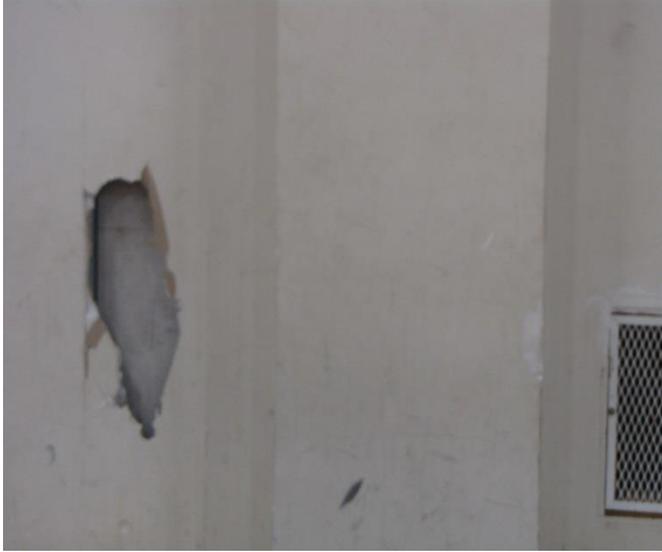
(Picture above)- another of the many holes (approximately 24"x12") in the gymnasium's interior wall needing repair

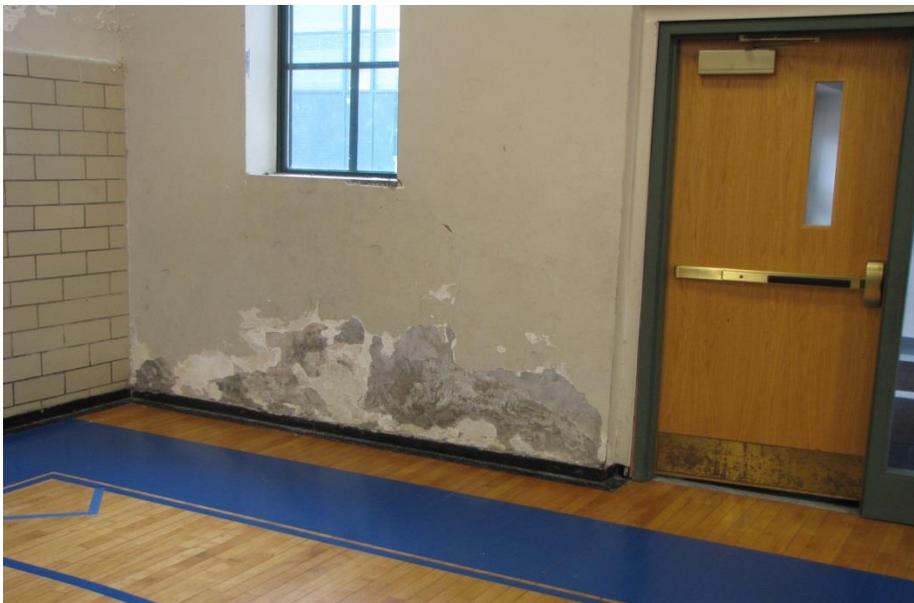
(Picture above) More wall damage that needs to be repaired.

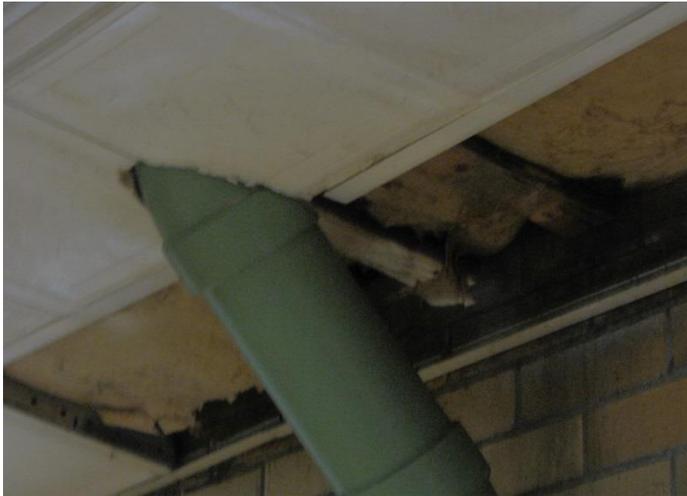
Building Roof and rain water system- Has reached its age limit is leaking in places and needs to be replaced although it can be patched up maybe for another year. Estimated cost is \$65,000-\$75,000. Downspouts run through the recreation center's main room and some are leaking (See picture below). We need a cost estimate for all of this work.

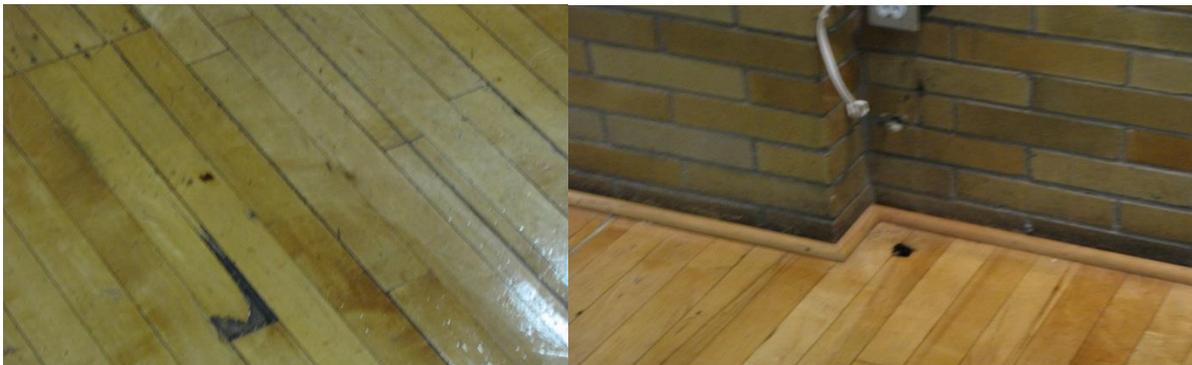
Floor replacement and removal of non-functioning hot water heating system- As shown in the pictures below, the floor cleans up nice but has holes, chips and other issues that can only be solved by replacement. Additionally, old non-functioning hot water heating system should be removed and floor replaced. We need a cost estimate for all of this work.

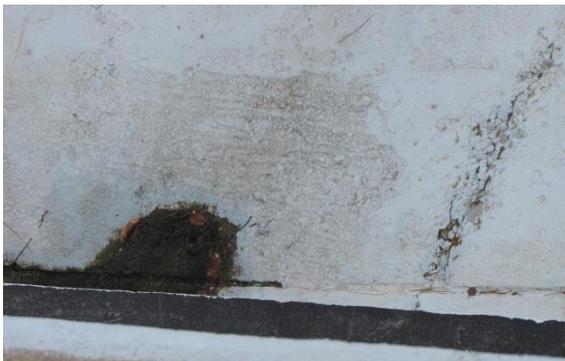
Groundwater infiltration- Last summer the Borough Engineer conducted a limited study on the pool's water usage. In short, the pool does not lose as much water as it should based on evaporation models. It is suspected and observations indicate that the pool is receiving groundwater infiltration. This was observed during the May 10 tour (see picture below of water bubbling up through the drain in the deep end of the dry pool) and may be one reason for the amount of chlorine that we use to maintain the appropriate level of chlorination.

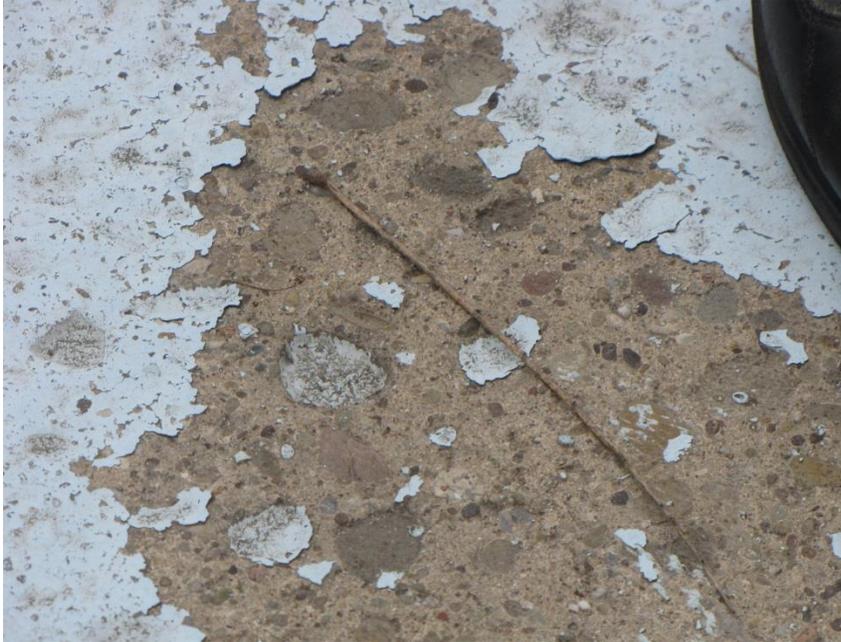
Paint, Slab and Joint Conditions- The pool was painted with a special paint in 2009-2010. The paint was supposed to seal the pool to stop groundwater infiltration and was under warranty to last for many years. However, it was reported that the paint began to fail (chip off) soon after its application. The Borough moved to invoke the warranty. Documents on record at the Borough indicate that the manufacturer rejected the warranty claim because of improper application of the product by the Borough's contractor. Observations made of the paint during the tour (see pictures below) , indicate that the paint continues to deteriorate and flake off making it less and less effective.

It appears that the integrity of the pool will continue to deteriorate even with the best efforts of our staff. It would seem prudent to have the pool be assessed by a pool expert and a structural engineer who can propose alternatives and prepare cost estimates.

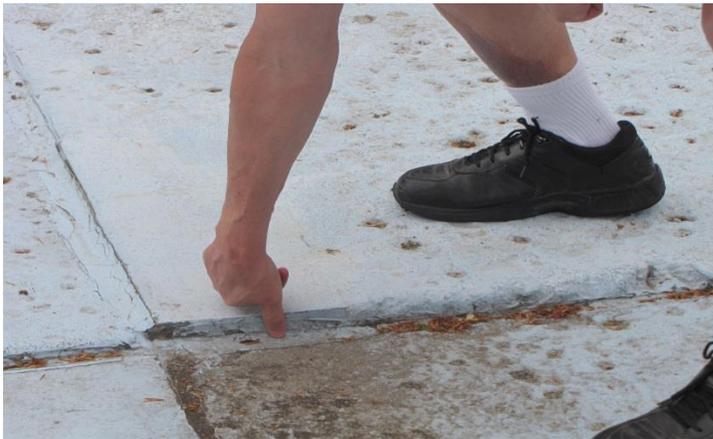
In addition to the paint failing, the concrete slabs that make up the pools bottom are raising (heaving) and/or sinking creating uneven joints in many areas (see picture below- also note the paint condition). This was particularly noticeable in the shallow end and may be uncomfortable obstacles for little feet.

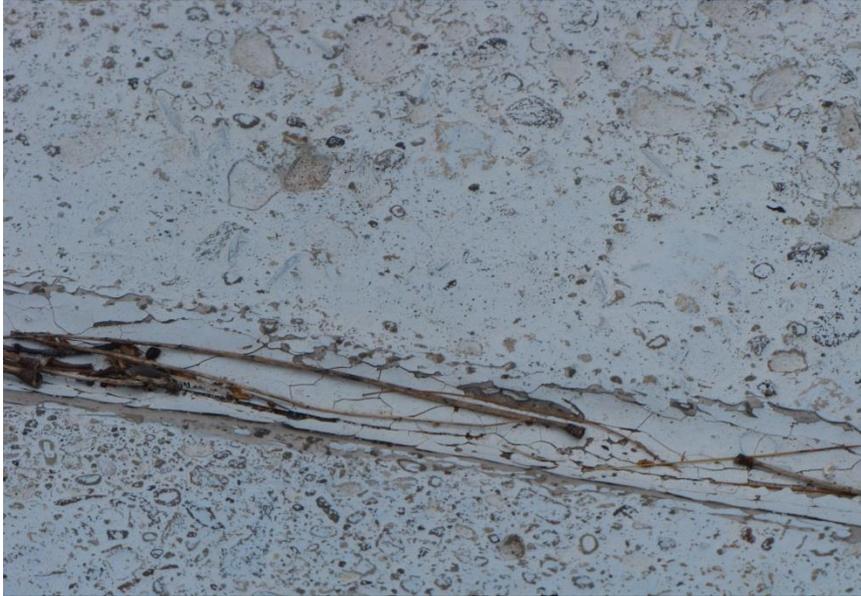
Finally, the combination of failing paint and slab movement clearly have an adverse effect on the integrity of the slab joints caulking material requiring it to be replaced annually – a labor intensive and time consuming maintenance task. **Note- Failing caulk seam in center of picture below.**

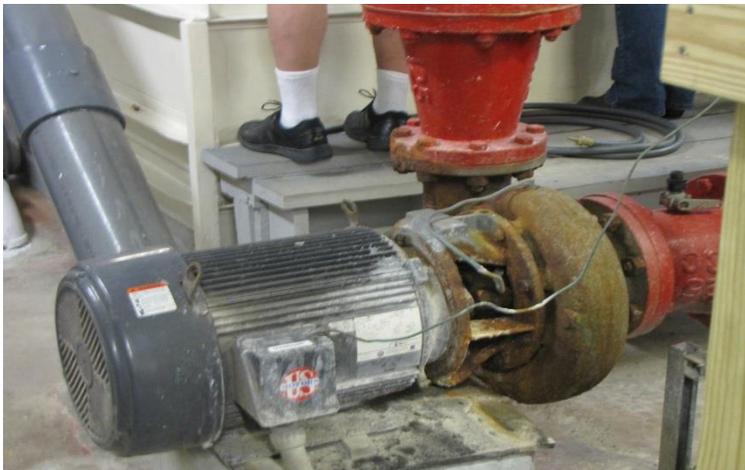
Pumps, Pipes and Filters- Three pumps work continuously circulating water that is filtered through diatomaceous earth filters. The pumps are 10, 6 and 5 years old. Mr. Conroy, also wisely has two pumps in stock and he and in-house staff can change out pumps. Some of the pipes are original (circa 1936) and are likely beginning to fail. Council was impressed with the condition of the old equipment and Mr. Conroy's clear commitment to its maintenance.

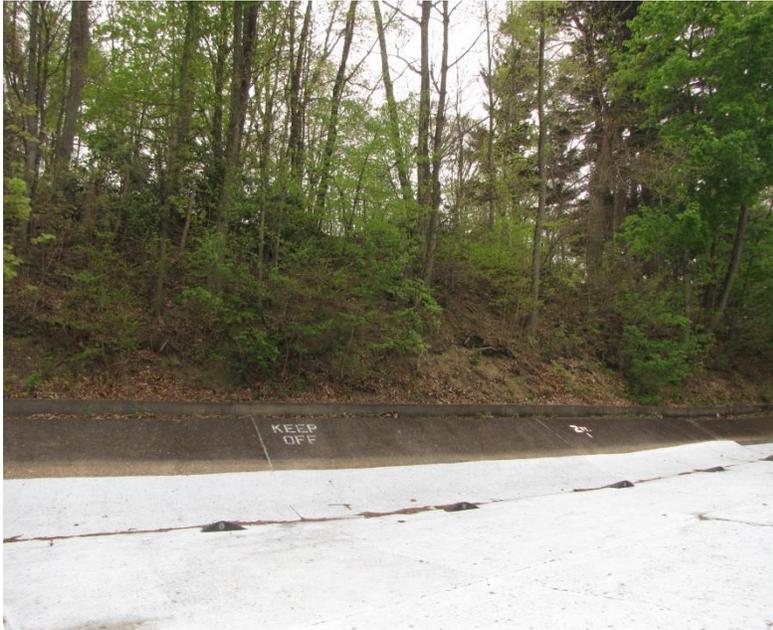
South east “bank”/wooded hillside- There is little to no groundcover on this bank (see picture below). During heavy rains it seems like that erosion of this bank will wash soil into the pool. Perhaps we should consider planting a ground cover (e.g., pachysandra, vinca, etc to hold and stabilize the soil. This would be a relatively low cost solution (ex. 500 vinc bare root plants cost about \$60.00).

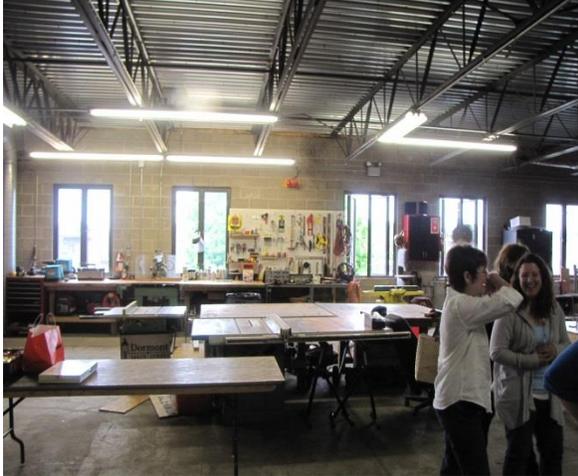
The Building- Like the Parks Department headed by T.J. Conroy, John Schneider and his staff take obvious pride in the facility in which they work both inside (see picture below) and out. The work effort and sense of responsibility and ownership would be the envy of any community. We are fortunate to have them working for us.

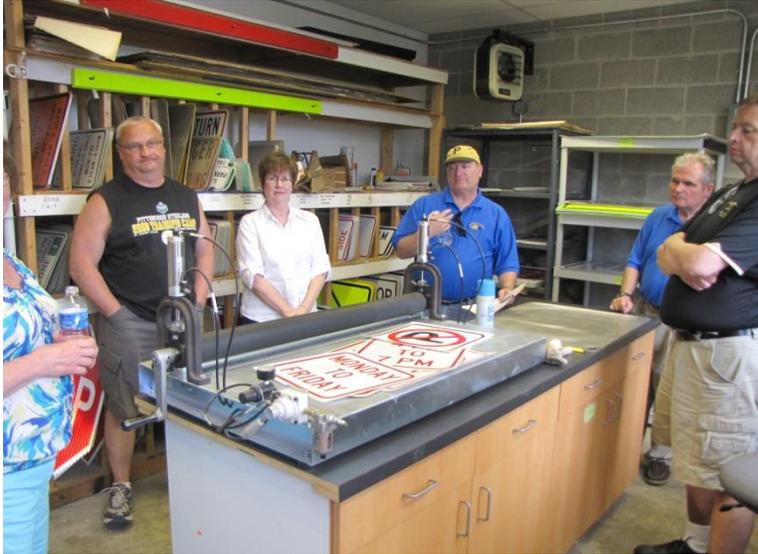
Mr. Schneider and his staff have developed a street sign facility (see picture below) and through its use have likely saved the Borough thousands of dollars by making new signs and recycling old street signs- all Borough street signs are reused unless very severely damaged is discarded. The propane activated post pounder and the hydraulic truck lift that the Borough purchased for them have already paid for themselves by allowing this staff to do more installations safely and efficiently and to more safely and efficiently perform maintenance on our vehicles and thus reduce the time it takes for work to be completed on many jobs.
