## SOLAR FEASIBILITY ANALYSIS

November 1st, 2013

The following analysis was conducted for the **Borough of Dormont** to determine whether the use of solar energy is feasible on the property known as the 'Dormont Pool and Recreation Center'. This feasibility analysis included inspections of the existing roof conditions, electrical systems of the building, shade analysis readings, a summary of the utilities bills for this property, a financial analysis and a proposed layout.

Borough of Dormont  
Dormont Pool House  
Dormont Avenue, Dormont, PA

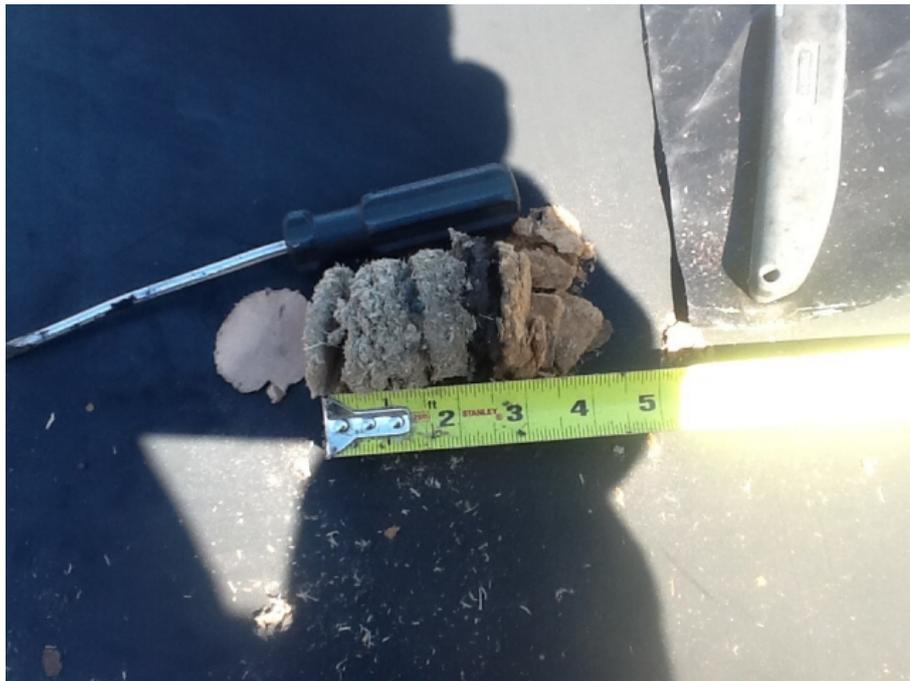
**Section:** Main Roof  
**Size:** 4,641  
**Overall Grade:** F

Core  
Wood  
Rosen Paper  
2.5" Perlite Insulation  
1/2" BUR  
1/2" Fiberboard Insulation  
.045 EPDM

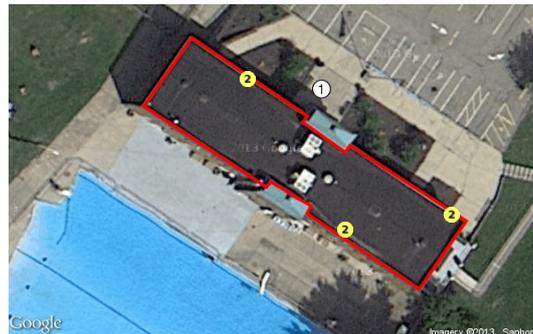
**General - Loose Debris (Remedial)**

Quantity: 50 SF

Loose debris has a high probability of blowing around on the roof and causing damage to the waterproofing membrane.

Remove loose debris from roof area.

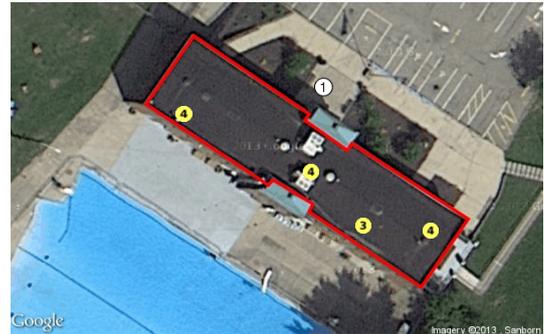
**General - Previous Repair Failure (Emergency)**

Quantity: 1 EA

Existing repair failing due to age or improper repair.

We will remove the existing repair, clean and prime area, and install new patch to ensure water tightness.

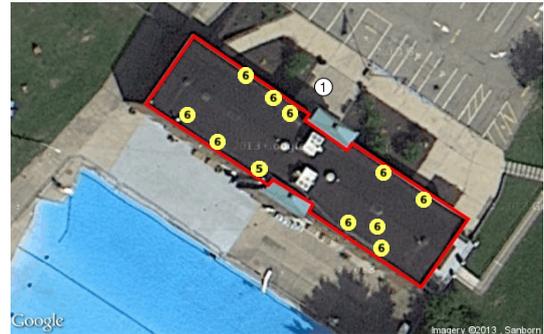
**General - Physical Damage (Emergency)**

Quantity: 1 EA

Replace the loose fasteners and overlay the open holes

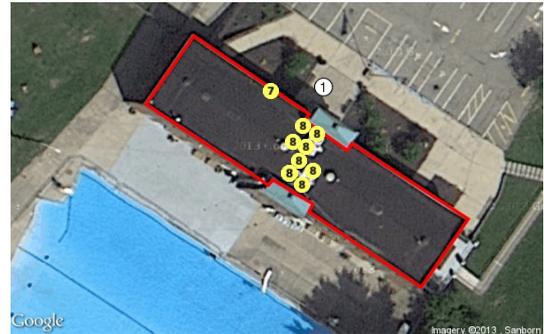
**General - Physical Damage (Emergency)**

Quantity: 1 EA

Damage to any roof system or drainage system that is caused by storms, negligence, or remodeling, etc. that is not consistent with normal weather or age-related conditions.

Repair or replace any damaged membrane or materials needed to restore the roof system or drainage system back to original condition.

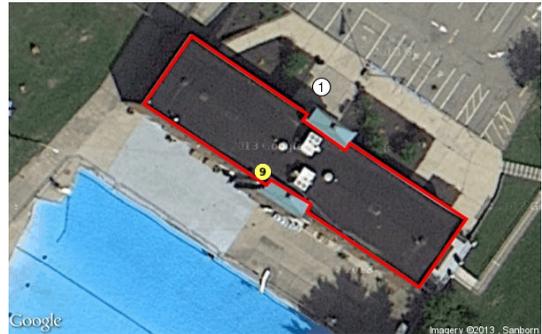
**General - Physical Damage (Emergency)**

Quantity: 2 EA

Damage to any roof system or drainage system that is caused by storms, negligence, or remodeling, etc. that is not consistent with normal weather or age-related conditions. The securement of the wire bracket has pulled out of the metal.

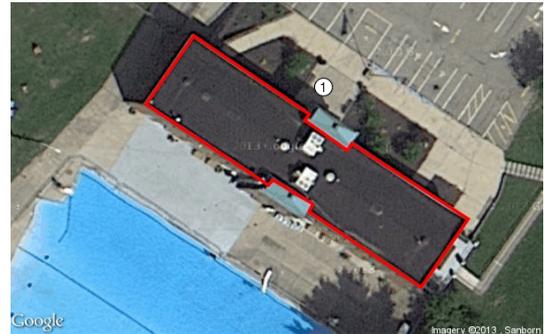
**Condition Summary**

Membrane: D  
Flashings: F  
Sheet Metal: D

Estimated Replacement: 2014

Due to the age and existing deterioration of this roofing system, our recommendation is the total replacement of this roofing system.

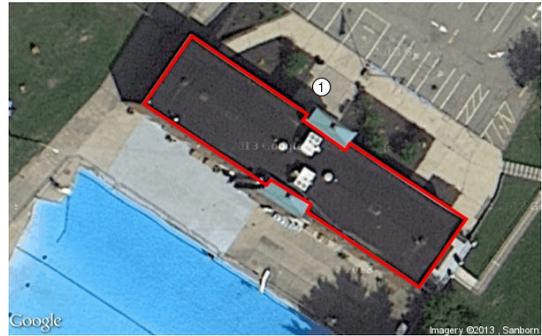
**1 - Main Roof (4,641 SF) Grade F**

**Section:** Main Roof  
**Size:** 4,641  
**Overall Grade:** F

Deficiency	Qty	Emergency	Remedial	Replacement
			\$0.00	
Loose Debris	50 SF		\$300.00	
Previous Repair Failure	1 EA	\$325.00		
Open Seams	100 LF	\$1,250.00		
Physical Damage	1 EA	\$275.00		
Bridging	1000 SF	\$22,500.00		
Physical Damage	1 EA	\$225.00		
Failing Penetration (Commercial)	8 EA		\$650.00	
Physical Damage	2 EA	\$450.00		
Full Replacement	4,641 SF			\$55,691.16
<b>Total</b>		<b>\$25,025.00</b>	<b>\$950.00</b>	<b>\$55,691.16</b>
