# Illicit Discharge Detection & Elimination Program (IDD&E) Annual Report

January 1, 2015 to December 31, 2015

**BOROUGH OF DORMONT**  
ALLEGHANY COUNTY,  
PENNSYLVANIA

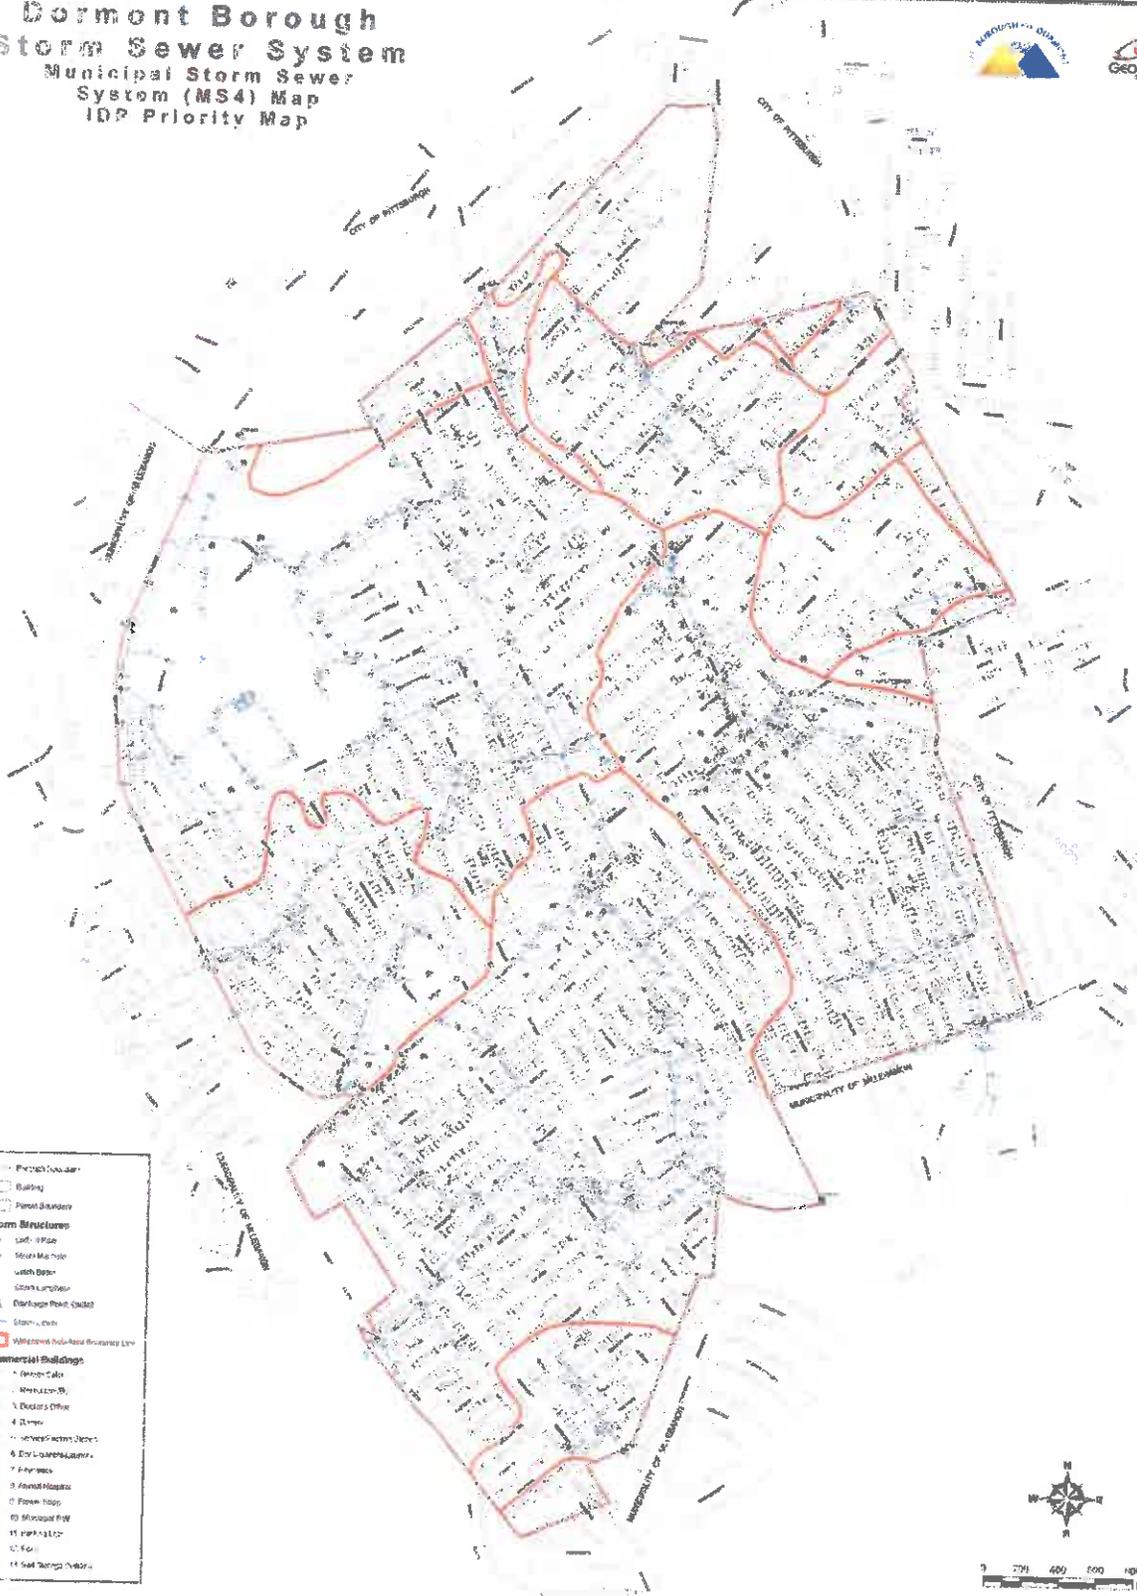
- - - - - Parcel Boundary
- ▭ Building
- ▭ Parcel Boundary
- Storm Structures**
- Catch Basin
- Storm Manhole
- ▭ Catch Basin
- ▭ Storm Lymphatic
- ▭ Discharge Point (Outlet)
- ▭ Storm Line
- ▭ Wetland/Invasive Species LSP
- Commercial Buildings**
- 1. Beach Club
- 2. Warehouse (B)
- 3. Doctor's Office
- 4. Store
- 5. Warehouse (A)
- 6. Dry Cleaning
- 7. Pharmacy
- 8. Food Market
- 9. Flower Shop
- 10. Storage Shed
- 11. Auto Wash
- 12. Gas
- 13. Gas Station (A)

The IDDE Program was initiated in 2015. During this year all outfalls were screened. No evidence of any illicit discharge at any outfall was detected. There was one citizen complaint that was received and acted upon. All outfalls were mapped and an IDP Priority Map was prepared.
